2004 MAZDA3 CRASH ZONE SENSOR [RECALL 2304J]

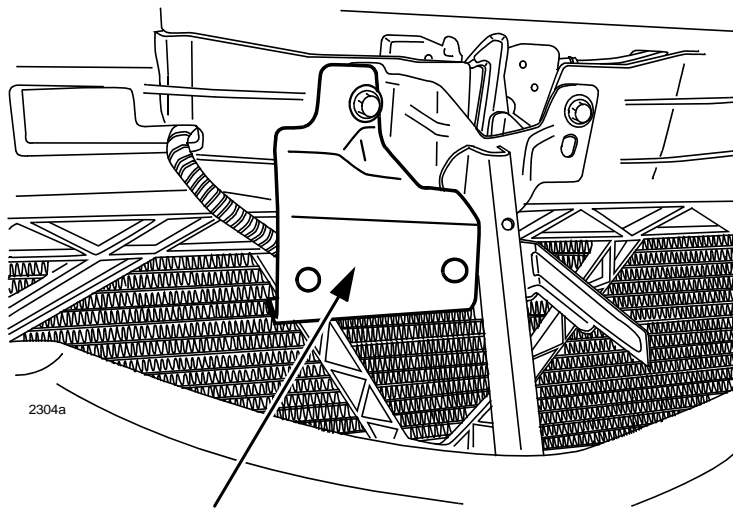
REMOVE COVER  
OF CRASH ZONE  
SENSOR

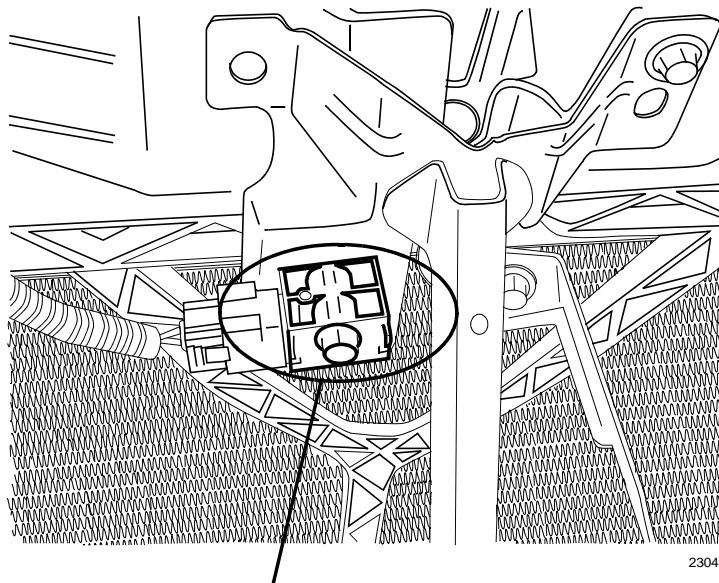
3. Inspect bolt for presence of white silicon at bolt head, end of bolt, and on top of the CZS surfaces.
  - If silicon is present, install cover, install recall sticker on hood, and return vehicle to the customer or inventory.
  - If silicon is not present, proceed to REPAIR PROCEDURE.

INSPECT THE PRESENCE OF WHITE SILICON  
AT BOLT HEAD, END OF BOLT, ON TOP OF,  
AND SURROUNDING SURFACES  
OF CRASH ZONE SENSOR
