**1999 Protégé with FMS Audio
Rear Speaker
[Recall 98011]**

SUBJECT: **Recall Campaign 98011**
1999 Protégé with FMS Audio – Rear Speaker

1999 PROTÉGÉ WITH FMS AUDIO [RECALL 98011] REAR SPEAKER

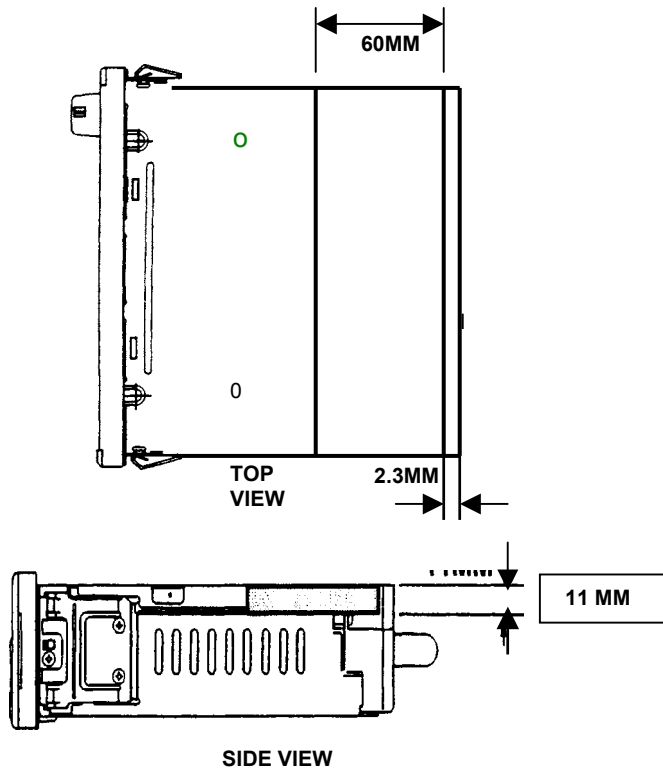
If the vehicle is operated at low speed in a hot and humid environment with the window open and the air conditioning and audio on, condensed water from the air conditioning duct surface may drip into the audio unit and cause a short circuit. If the short circuit occurs at one specific set of terminals, the rear right speaker can overheat and in some cases catch fire.

- Pull the SST (removal tool) outward and forward to slide out the audio unit.
- Disconnect the audio connector, antenna jack and remove audio unit.
- Place audio unit on a flat, clean work area and install protective tape using the dimensions shown in the following illustrations.

During installation of the tape, do not remove the entire piece of tape from its backing material. Instead, start one end of the tape and slowly apply it as you go along the top of the audio unit.
