**1995 Protege  
Airbag System  
[Special Service Program - SSP 26]**

**SUBJECT:** **Special Service Program – SSP26**  
1995 Protege - Airbag System

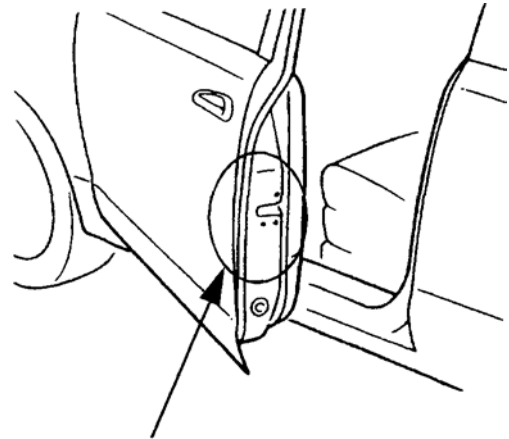
Fig.-1

2. Perform a **Warranty Vehicle Inquiry** using your **MDCS System** and inspect vehicle for an Authorized Modification Label **SSP26** attached to the drivers side door. Refer to illustration.

Inspect This Area For SSP26 Label

1. Install Authorized Modification Label on driver's side door. Refer to Fig. 1.

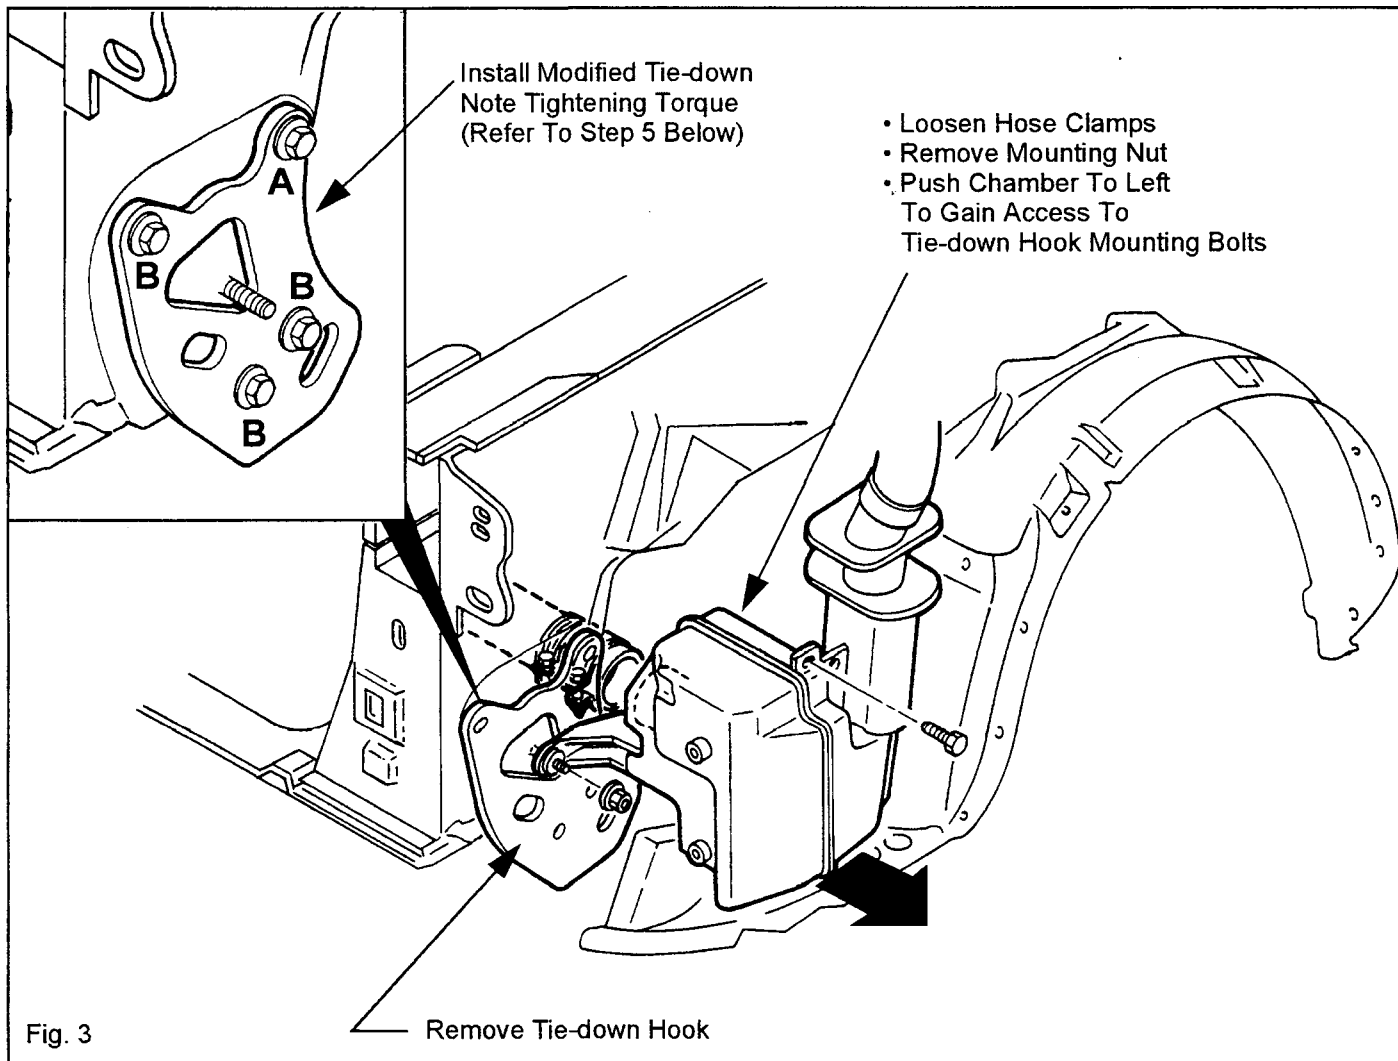
**Mazda** has learned of cases in which the airbags have inflated as the result of the tie down hooks striking a curb or pavement. These cases usually occur if the vehicle travels off the side of the road, over a curb, or through a deep pothole. In some of these cases, the airbag inflation was probably not necessary to protect the driver or the passenger.

3. Remove the resonance chamber mounting nut and move the chamber to the left side of the vehicle.
4. Remove the four (4) tie-down hook bolts (left side) and remove the tie-down hook.
5. Install the modified tie-down hook (p/n BC1D 53 364ATT). Refer to Fig. 3 **Tightening Torque Bolt "A":** 4.4 - 6.9 kgf-m (32 - 50 ft-lbs)  
**Tightening Torque Bolts "B"** 3.7 - 5.5 kgf-m (27 - 39 ft-lbs)

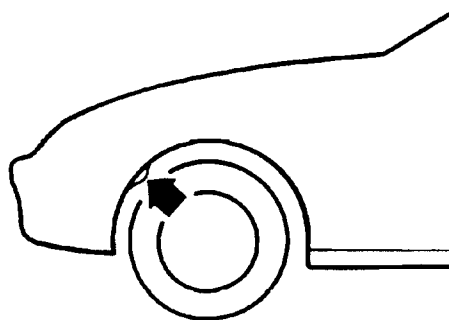
Outer Wheel Well Should Not Exceed From Fender

6. Install resonance chamber and outer wheel well.  
**NOTE:** Install outer wheel well along fender, do not allow to extend past fender. Refer to Fig. 4
7. Remove and replace tie-down hook on right side.
