Subject: MAZDA SERVICE PROGRAM (MSP30) - BLUETOOTH HANDS-FREE PHONE SYSTEM INOPERATIVE	Bulletin No: 09-038/10
	Last Issued: 08/24/2010

On some vehicles, the "Talk", "Pick-Up" and "Hang-Up" buttons may not function.

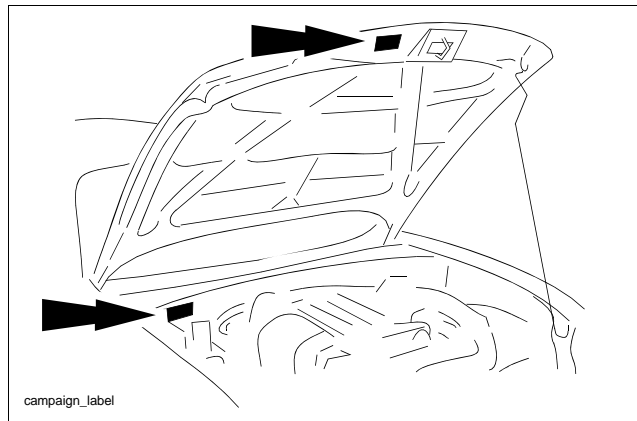
2. Perform a Warranty Vehicle Inquiry using your eMDCS System and inspect the vehicle for a Campaign Label **MSP30** attached either to the vehicle's bulkhead or to the vehicle's hood. Refer to eMDCS System - Warranty Vehicle Inquiry Results table below.
