Category 01	Applicable Models 1999-2003 PROTEGÉ	Subject EGR VALVE SEIZED (DTC P0300, P0401)	Bulletin No. 07-17
			Issued 06/07
			Revised

Attachment - EGR Control Valve Stuck (DTC P0300, P0401)

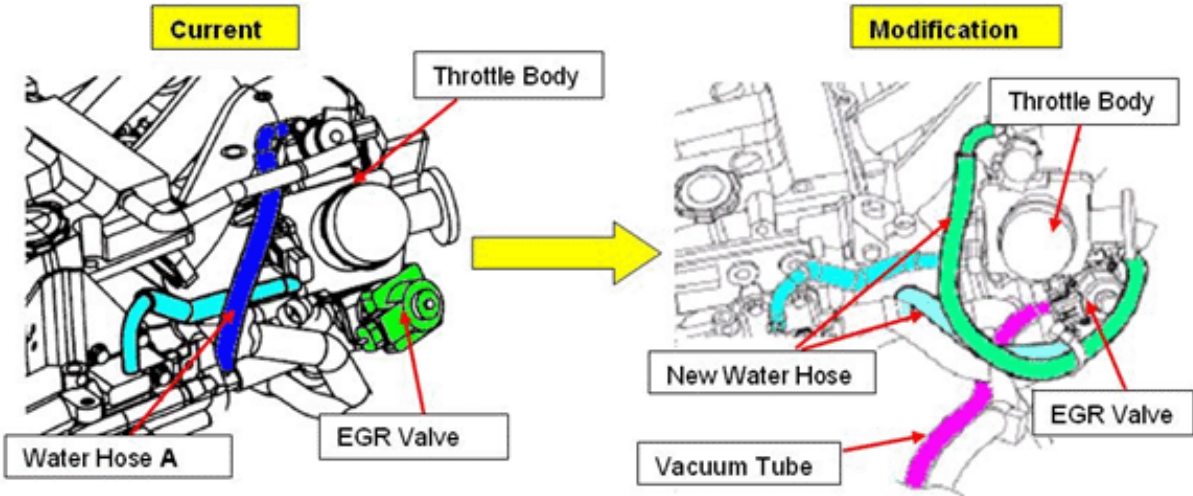
The EGR valve has been modified by the addition of a water hose and a vacuum tube. The original water hose 'A' will not be reused, so please discard it.

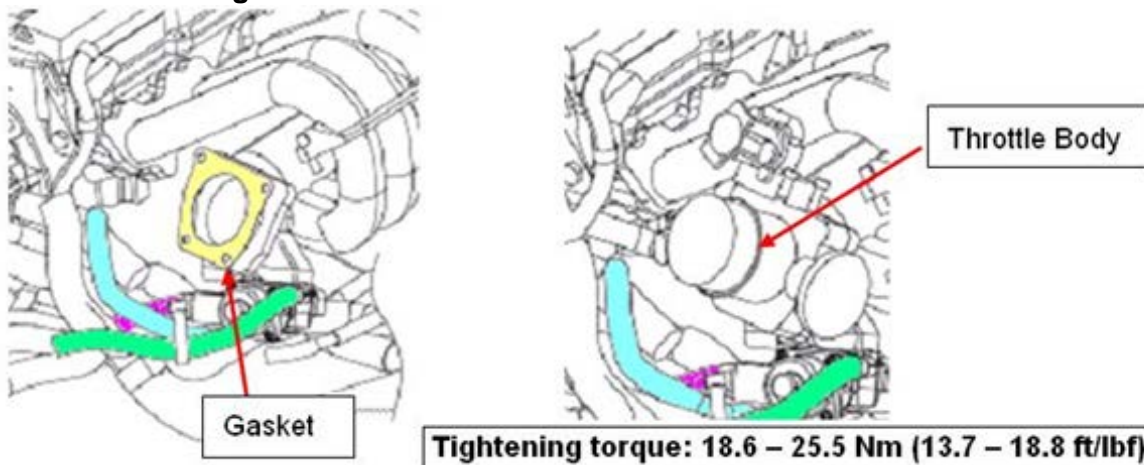
- Care must be taken to ensure that none of the old gasket is left in the throttle body and intake manifold when the clean rag is removed. Failure to do so may result in “rough idle” or “high idle” concerns.

7. Install the throttle body and a new gasket to intake manifold. Tightening torque: 18.6 – 25.5 Nm (13.7 – 18.8 ft/lbf)

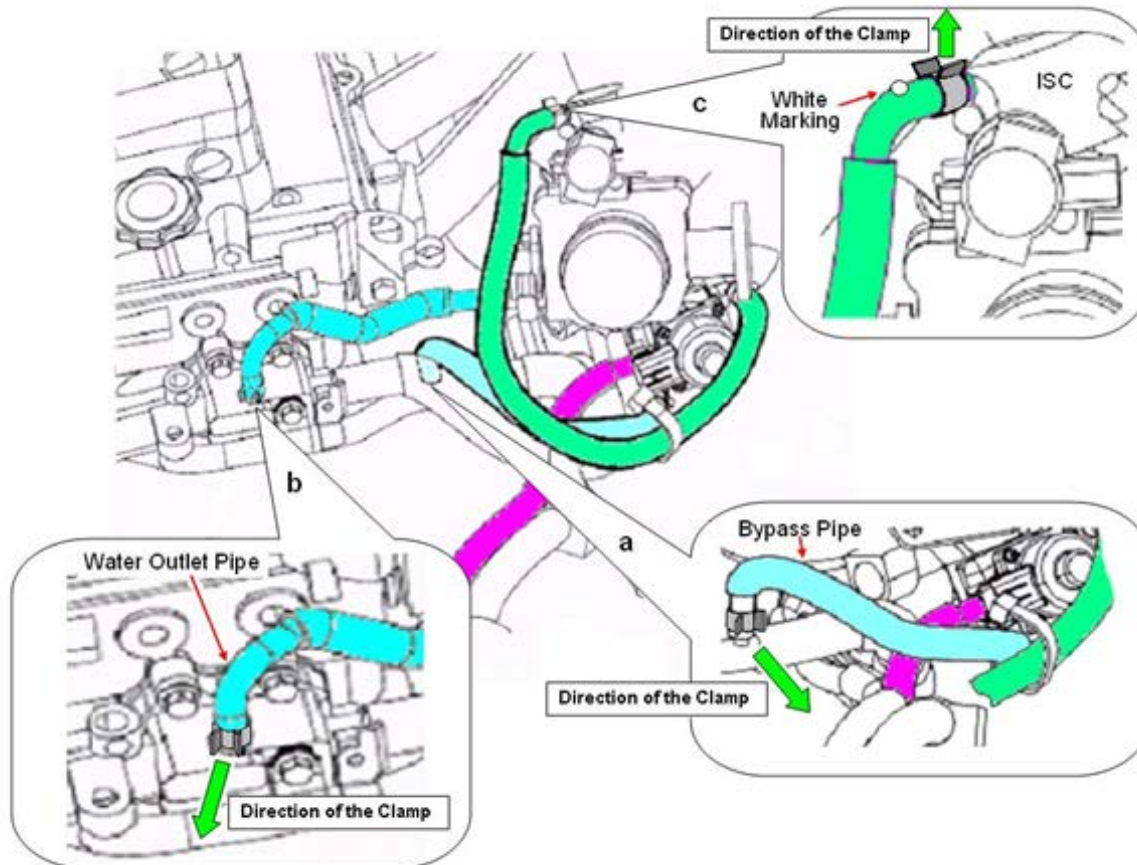
- Use the new clamps to secure the water hose in the bypass pipe and ISC.
- Once in position, in order for the clamps to be secure, the holders must be removed and the clamps released in the proper position as illustrated below.

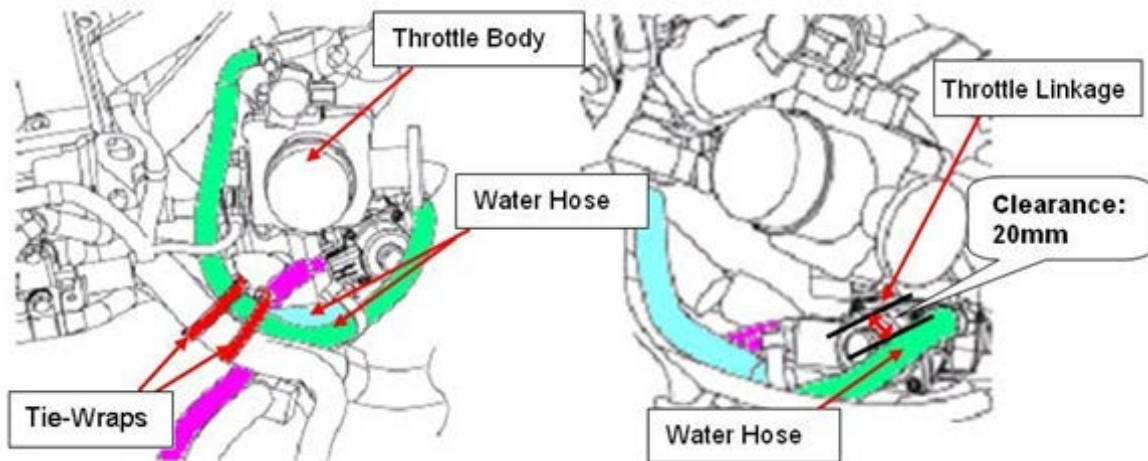
- If the water hose contacts the throttle linkage, it could potentially cause the throttle to stick open. Therefore it is extremely important to make sure that no interference exists between these parts.

9. Tie-wrap the water hose and harness together as shown in the following picture. (2 locations)
Make sure there is approximately 20 mm clearance between the water hose and the throttle linkage.
