Category 01	Applicable Models 1999-2003 PROTEGÉ	Subject EGR VALVE SEIZED (DTC P0300, P0401)	Bulletin No. 07-17
			Issued 06/07
			Revised

Attachment - EGR Control Valve Stuck (DTC P0300, P0401)

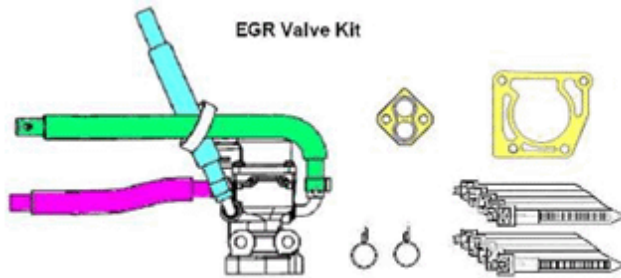
The kit (FSY1 18 W00) should be inspected to ensure that all components are present.

- 1 EGR valve
- 10 tie-wraps
- 2 clamps
- 1 EGR gasket
- 1 throttle body gasket
