Subject: MAZDA SERVICE PROGRAM (MSP23) - MIL ON WITH P2183 AND/OR P0111	Bulletin No: 01-023/11
	Last Issued: 06/07/2011

2010 Mazda3 vehicles produced from October 7, 2008 through April 23, 2009

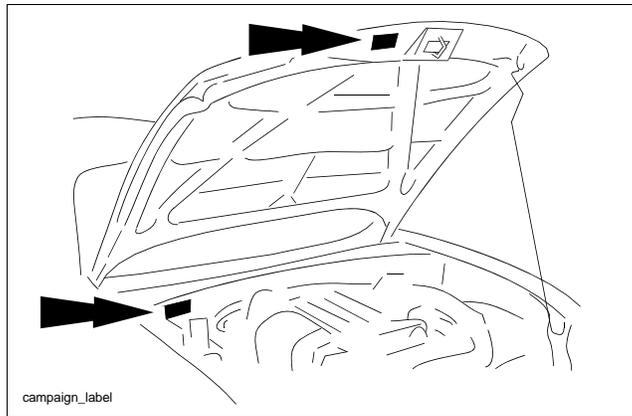
1. Verify the vehicle is within the following VIN range and produced between Oct. 7, 2008 through Apr. 23, 2009:
 - 2010 Mazda3
 VIN Range: JM1BL****A1 100120 - 152216
 - If the vehicle is within the above VIN range, and produced between Oct. 7, 2008 through Apr. 23, 2009, proceed to Step 2.
 - If the vehicle is not within the above VIN ranges, return the vehicle to the customer or inventory.
2. Perform a Warranty Vehicle Inquiry using your eMDCS System and inspect the vehicle for a Campaign Label **MSP23** attached either to the vehicle's bulkhead or to the vehicle's hood. Refer to eMDCS System - Warranty Vehicle Inquiry Results table below.

NOTE: Verify the campaign number as the vehicle may have multiple labels.

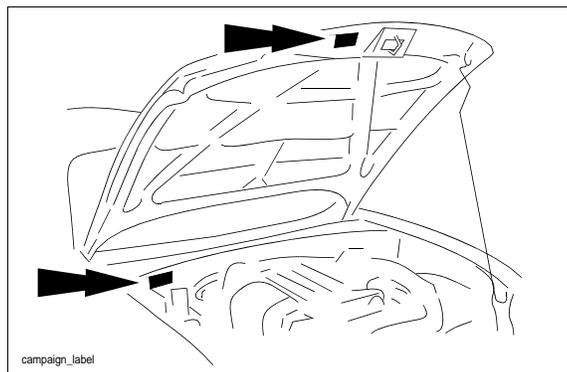
- If any DTCs should remain after performing DTC erase, diagnose the DTCs according to the appropriate Troubleshooting section of the Workshop Manual.
 - After PCM reprogramming, it is no longer necessary to road test the vehicle to relearn KAM (Keep Alive Memory).
4. Fill out a blue "Campaign Label" (9999-95-065A-06) with the Campaign No: "MSP23", your dealer code, today's date, and affix it to the vehicle's bulkhead or hood.
