A. VEHICLE INSPECTION PROCEDURE

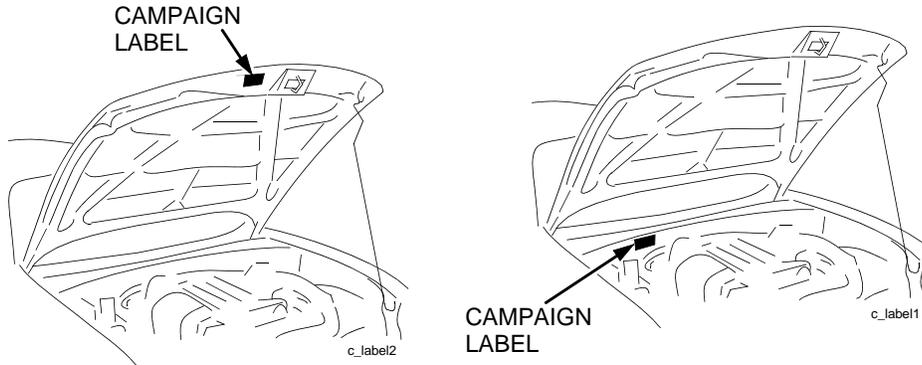
1326b

CAMPAIGN LABEL	
CAMPAIGN NO:	_____
DEALER CODE:	_____
DATE:	/ /
P/N 9999-95-065A-05

2. Perform a Warranty Vehicle Inquiry using your eMDCS System and inspect vehicle for a Campaign Label **SSP69** attached to the vehicle's hood or bulkhead. Refer to eMDCS System - Warranty Vehicle Inquiry Results table below.
