A. VEHICLE INSPECTION PROCEDURE

Recall 4407B

MAZDASPEED3 - GENUINE MAZDA ALL WEATHER FLOOR MAT

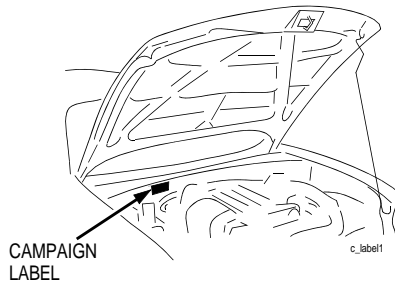
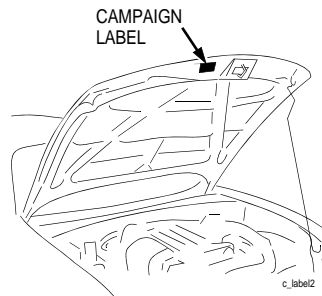
1. Verify that the vehicle is within the following ranges:
 - Year Range (2007) Model (Mazdaspeed3) VIN: (JM1BK34*-603266 through 695052)
 - If the vehicle is within the above range, proceed to step 2.
 - If the vehicle is not within the above range, return the vehicle to the customer or inventory.
2. Perform a Warranty Vehicle Inquiry using your eMDCS System and inspect vehicle for a Campaign Label **4407B** attached to the vehicle’s hood or bulkhead. Refer to eMDCS System - Warranty Vehicle Inquiry Results table below.

Complete an "Campaign Label" with the Recall number written on the sticker and affix it to the vehicle's hood or bulkhead. Refer back to the illustration under "A. VEHICLE INSPECTION PROCEDURE".

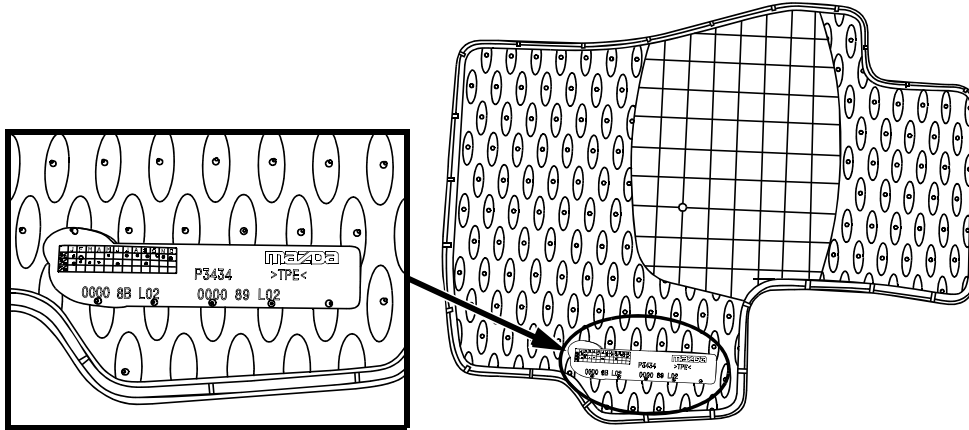
1. Inspect the vehicle for genuine Mazda all-weather floor mats.
2. Look at the back of the driver's side all-weather floor mat and confirm the part number as shown.
 - If part numbers are 0000-8B-L02 and 0000-89-L02, go to REPLACEMENT.
 - If part numbers are NOT 0000-8B-L02 and 0000-89-L02, go to CAMPAIGN LABEL INSTRUCTIONS.

REPLACEMENT

1. Remove or collect both front genuine Mazda all-weather floor mats from the vehicle or the customer.
2. If available, put the customer's original equipment (Mazdaspeed3) carpet floor mats in. If they are not available, request the customer to put them in.
3. Attach a copy of the REPAIR ORDER and CUSTOMER ADDRESS SHEET to the removed all-weather floor mats.
